Circular No. 129 / 2023

**Field Safety Corrective Action of Oxylog 3000 plus from Draeger Medical Systems Inc.**

## Important Safety Notice

Oxylog 3000 *plus* may not switch to mains supply following battery operation.

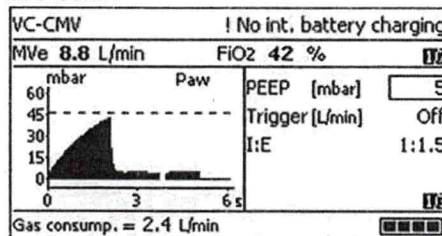
The root cause of the inability to switch to mains supply could be identified as a problem of the charging circuit which can occur in the following sequence of situations:

1. a prior battery issue indicated by the alarm "No int. battery charging" occurred during use on mains supply – see below

Please make sure that the battery is always removed and reinserted or replaced after occurrence of the "No int. battery charging" alarm message, without removing the device from mains supply.

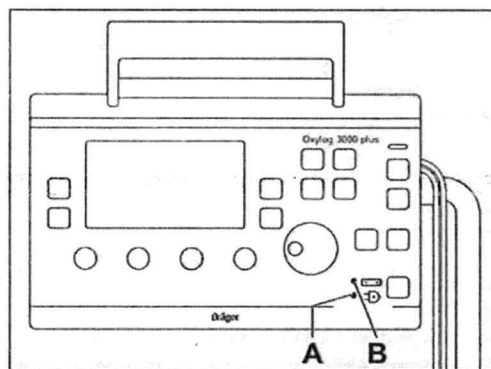
A should display a green light, and B should display a green or yellow light. If B displays a red light, you should disconnect and reconnect or replace the battery.

Prior to a device being used on a battery supply, ensure the correct switchover by disconnecting from and reconnecting the device to a mains supply. Please verify the colors of indicators A and B as per the diagram below:

Your local Dräger Service representative or our service partner will contact you to arrange a date for a firmware update of the Printed Board Assembly Charger to be performed free of charge.
