Circular No. 148/2023

Field Safety Corrective Action of Allura Xper and Azurion systems from Philips Healthcare.

URGENT Field Safety Notice

Allura Xper and Azurion systems
Potential for wireless foot switch loss of availability

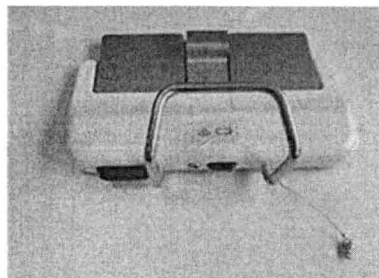
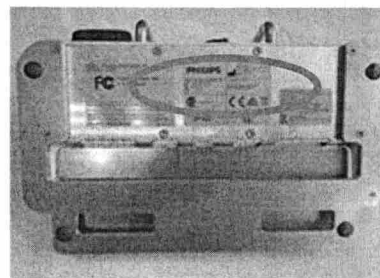
Figure 1: Label location on the bottom of the foot switch

The model number can be found on the label located on the bottom of the foot switch, as shown in Figure 1.
