**Recall of Liko M220, Liko M230 from Liko AB.**

## Field Safety Notice

**FA 2021-010-002-LUL-001**

**Subject:** Missing bushing on Liko M220 and M230 causing wear and potential for falls.

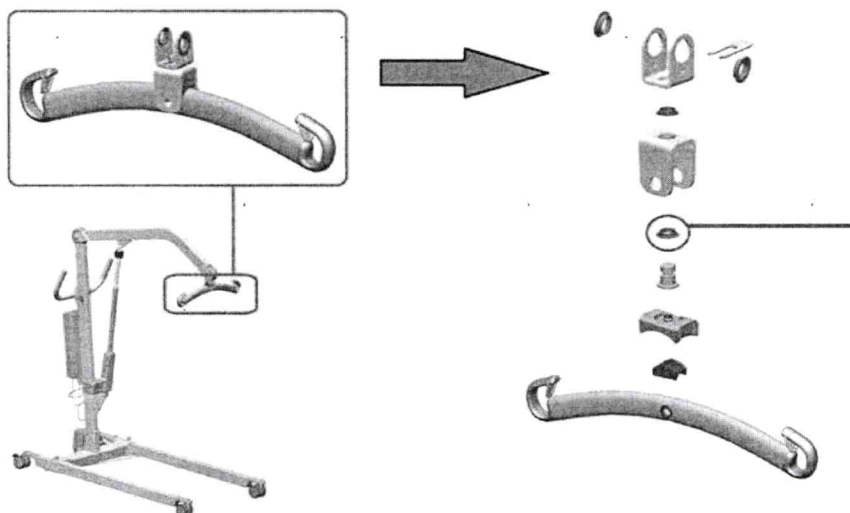
Figure 1: Mechanism and parts included in the sling bar for M220/M230. Bushing marked in red.

Hillrom investigation determined that the root cause of the slingbar detachment is caused by wearing at the slingbar attachment due to the missing of a plastic bushing (see red markings in Figure 1) as part of the assembly during manufacturing of the device. It was determined that assembly of this device has the potential to not contain this plastic bushing on devices manufactured between 2016-DEC-27 and 2021-SEP-01.

A missing plastic bushing on the device can cause wearing on the slingbar attachment. Over time, this wearing can cause the slingbar to detach from the lift, which may result in a patient fall. Hillrom can confirm there have been no death or serious injuries reported from this failure.

Upon receipt of the response form, identifying potentially impacted devices, Hillrom or an official Hillrom distributor/representative will be in contact to schedule inspection of your device to confirm presence of the bushing. Where it is confirmed that the device is missing the bushing, a replacement slingbar with the bushing will be installed.

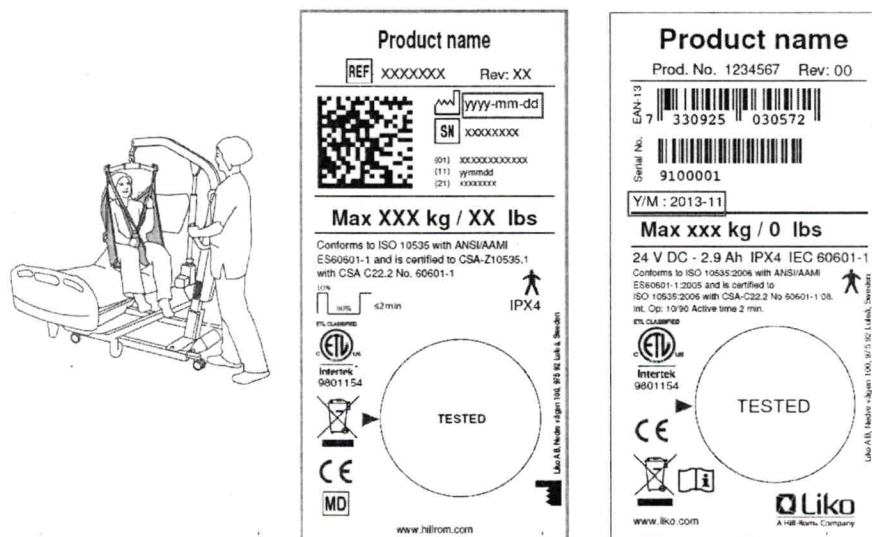
Figure 2: Placement of the label and its designs. Left: New design. Right: Old design.

1. Review the product label on your Liko M220/M230 to determine if it is impacted by this field action by identifying the manufacturing date of the device (i.e. Manufacturing date between 2016-DEC-27 and 2021-SEP-01). See figure 2.
