Circular No. 182 / 2024

Field Safety Corrective Action of Oxylog 3000 plus from Draeger Medical, Inc.

Update on Important Safety Notice

Important Safety Notice

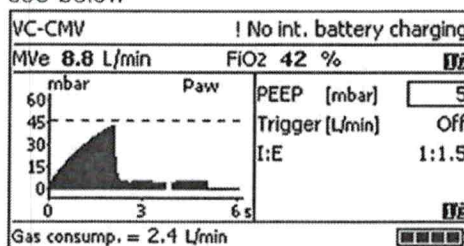
The root cause of the inability to switch to mains supply could be identified as a problem of the charging circuit which can occur in the following sequence of situations:

1. a prior battery issue indicated by the alarm "No int. battery charging" occurred during use on mains supply – see below

2. the internal battery is NOT removed and reinserted or replaced as recommended as remedy for this alarm message according to the Instructions For Use (IFU) and
3. the device is disconnected from mains supply (e.g., for patient transport) and
4. the device is reconnected to mains supply.

Only if all the conditions are fulfilled and after the aforementioned alarms were given, ventilation could stop as soon as the battery charge was depleted.

Please make sure that the battery is always removed and reinserted or replaced after occurrence of the "No int. battery charging" alarm message, without removing the device from mains supply.

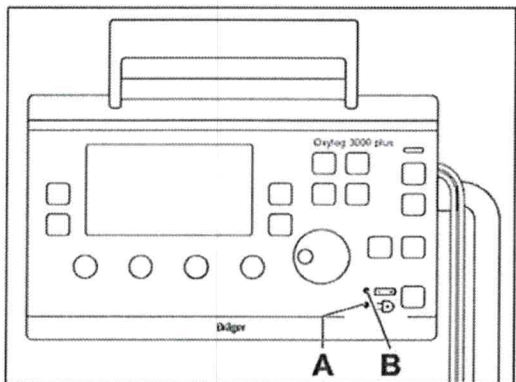
Prior to a device being used on a battery supply, ensure the correct switchover by disconnecting from and reconnecting the device to a mains supply. Please verify the colors of indicators A and B as per the diagram below:

A should display a green light, and B should display a green or yellow light. If B displays a red light, you should disconnect and reconnect or replace the battery.
