Circular No. 61 / 2023

Field Safety Corrective Action of Accelerator a3600 from Inpeco S.A.

Urgent Field Safety Notice

FSCA-identifier: FSCA – ACP – 202303 – 02

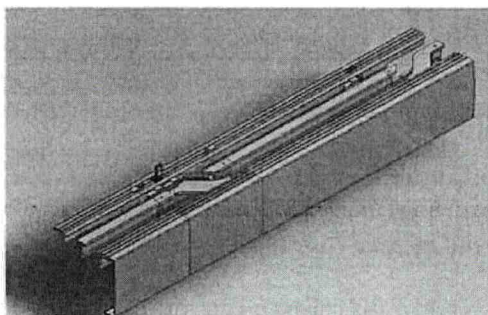
To avoid the occurrence of the described issue Inpeco recommends to visually check every day the gates at the buffer lane entry of the impacted modules (refer to Image 1) to verify that:

Image 1: Divert gate position

If the visual check is not passed, contact your local technical support for assistance before using the Automation System impacted modules to process samples.

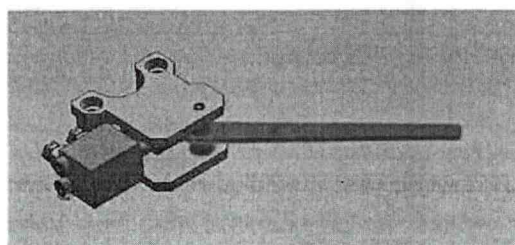
- there are no obstructions that prevent the correct activation and movement of the divert;
- the divert looks to be intact, refer to Image 2;
- the position of the divert is aligned to the profiles when it is diverting a tube, refer to Image 3; tubes that need to be routed by the module are diverted fluidly, without any missing or partial block of the carrier.

Image 2: Divert appearance

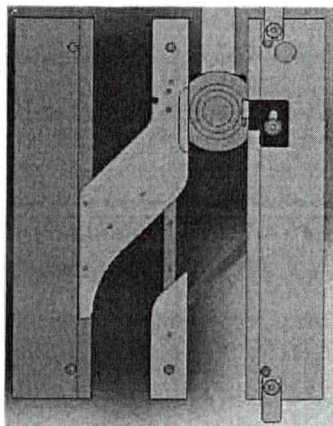
Image 3: Divert alignment
