Circular No. 41 / 2023

Field Safety Notice of BD Alaris™ System PC Unit 8015; Alaris™ PC Unit 8015 from Becton Dickinson & Co. (BD).

PRODUCT NOTIFICATION – MMS-23-4612

BD Alaris™ System PC Unit 8015; Alaris™ PC Unit 8015

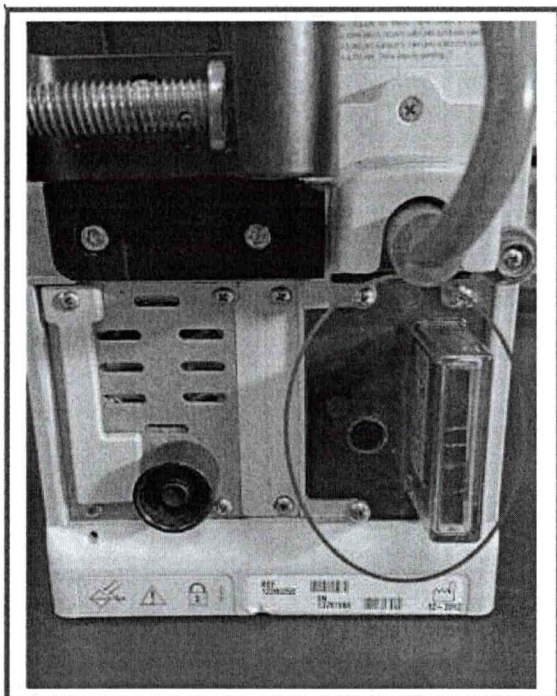
Based on customer feedback, BD has identified that when a BD Alaris™ System PC Unit with software versions 12.1.0, 12.1.1, 12.1.2 or 12.1.3 is used with a **802.11 b/g** or **802.11 a/b/g** wireless network card (refer to Figure 1), failure to establish a network connection can occur for IP addresses that are in a specific range from, **x.x.x.224** to **x.x.x.255**.

Figure 1: The back of the BD Alaris™ System PC Unit with the 802.11 b/g or 802.11 a/b/g wireless network card; the wireless network card protrudes out from the Alaris PC Unit.

A BD Alaris™ System PC Unit with this wireless network card is impacted by the issue.

- i. Exclude IP address ranges ending in **x.x.x.224** to **x.x.x.255** from all the DHCP scopes where the BD Alaris™ System PC Units are being utilised.
- ii. Assign the BD Alaris™ System PC Units IP addresses utilising DHCP reservations to prevent the BD Alaris™ System PC Unit from obtaining an IP address in the aforementioned range.
- iii. Assign the BD Alaris™ System PC Units a static IP address outside of the aforementioned range.

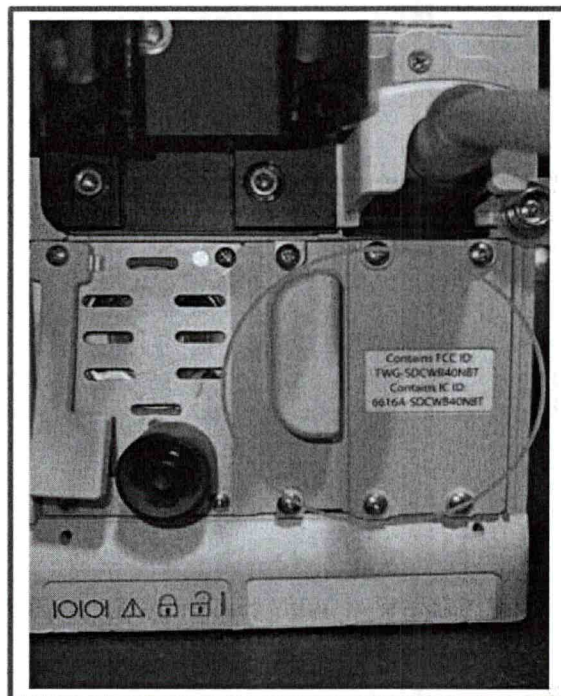
BD Alaris™ System PC Unit with the **802.11 a/b/g/n** wireless network card (refer to Figure 2) is not impacted by this issue.

Figure 2: The back of the BD Alaris™ System PC Unit with the 802.11 a/b/g/n wireless network card; the wireless card is near flush with the Alaris PC Unit.

A BD Alaris™ System PC Unit with this wireless network card is not impacted by the issue

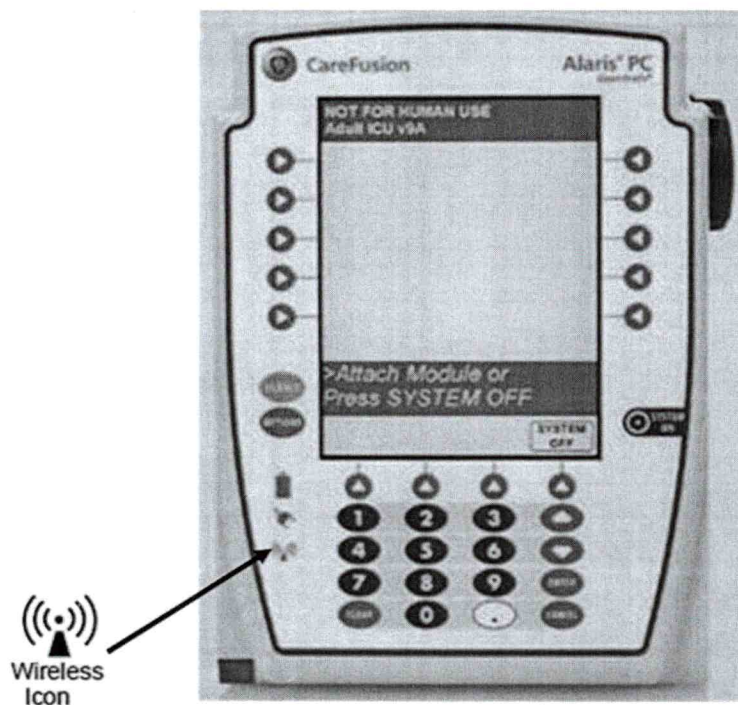
Appendix 2- image to show the BD Alaris™ System PC Unit front panel with the Wireless Network Indicator Icon

Figure 4; When the wireless network indicator icon is illuminated, the BD Alaris™ PC System Unit is connected to the wireless network

9. When using the BD Alaris™ System PC Unit for wireless network connection, ensure that the wireless network indicator icon is illuminated on the front panel of the unit (refer to **Appendix 2**). Users can also check the wireless status through the Systems Options menu on the Alaris™ PC Unit.
