Circular No. 182/2023

**FSCA of Datascope Cardiosave Hybrid and Rescue Intra-Aortic Balloon Pumps (IABP) from Getinge.**

**URGENT FIELD SAFETY NOTICE  
MEDICAL DEVICE CORRECTION**

**FSCA 2249723-06/02/2023-009-C & FSCA 2249723-06/02/2023-012-C  
Datascope Cardiosave Hybrid and Rescue Intra-Aortic Balloon Pumps (IABP)**

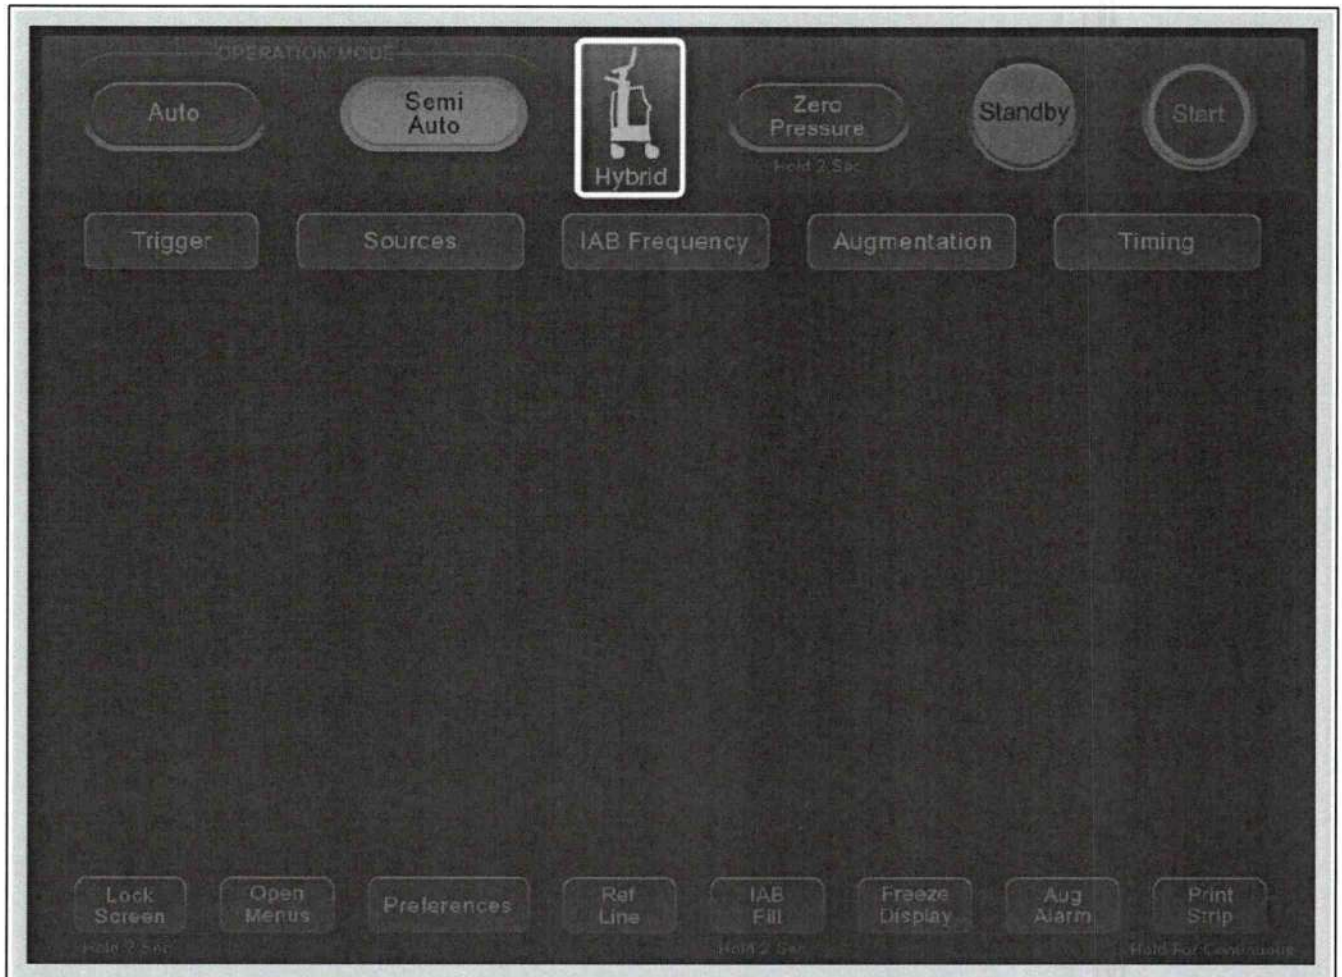
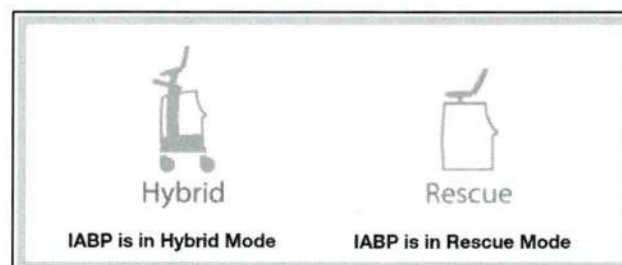
The IABP Configuration Icon shows the current mode of configuration for the IABP, Hybrid (in the hospital cart) Mode or Rescue (transport) Mode. The icon is located at the top center of the IABP display screen.

There are two methods where the IABP can be in transport/rescue mode without user intent:

- 1) The Cardiosave Hospital Cart's release latch has been released and the IABP console is not properly installed in the cart.

Additionally, in both scenarios, the Cardiosave will not receive AC power and if the device is in operation, it will continue to operate on battery. When the Cardiosave is not receiving AC power, the batteries are unable to charge.

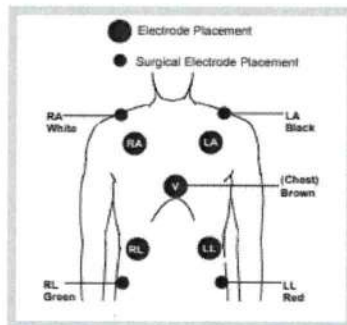
Figure 2-1: Electrode Placement AHA

The type of skin electrode and application technique are major factors in determining the quality of the signal obtained. Use of MAQUET/Datascope electrodes is recommended. These are designed to acquire an ECG signal with excellent baseline stability, recovery from defibrillation and minimum artifact from patient movement. The use of Wet-Gel electrodes is recommended because, in general, they provide a better quality electrical contact immediately after being placed on the skin.

To ensure the safe and effective use of the Cardiosave IABP, follow the recommendation in the IFU, including the warning and Figures 2-1 and 2-2 regarding ECG lead placement locations and the use of third-party lead wires.

- b. Attach electrodes to the patient at the appropriate locations, as shown.

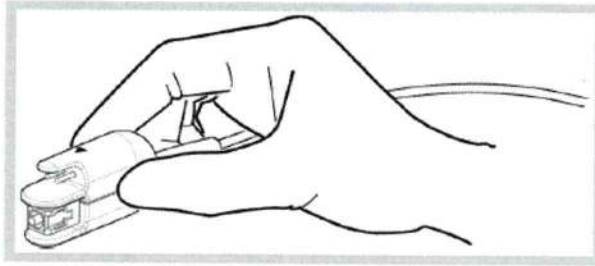
Figure 2-5: Grasping the Fiber-Optic sensor connector

The Fiber Optic connector is designed to fit smoothly into the IAB Sensor Input. The red triangle on the top of the connector should align with the red triangle on the Cardiosave console. Inserting the Fiber Optic connector into the port without verifying the correct alignment can lead to internal damage. If difficulty is encountered when inserting the connector, verify that the connector is in the correct position and attempt to reinsert into the IAB Sensor Input.

Excessive force can cause damage to the connector and the internal fiber optic assembly of the IABP console. This may cause a disruption in the fiber optic signal acquisition resulting in an inability to acquire a fiber optic signal on the Cardiosave IABP. Following proper insertion procedures will minimize the potential for damage to the connector and a loss of signal. This conclusion is based on field observations seen through the complaints evaluation. As part of Datascope's investigation testing will be performed to confirm this observation.

Damaged Fiber Optic ports may not present as an immediate failure. There is a potential for the damage to cause an intermittent or delayed failure in the Fiber Optic connection.

1. With one hand, grasp the Fiber-Optic Sensor Connector as shown in Grasping the Fiber-Optic sensor connector, with the red triangle visible on top.

In step 4, when the Fiber-Optic connector is inserted into the IAB Sensor input until an audible "click" is confirmed, ensure that you are not using excessive force as that can lead to damage to the Cardiosave.
