Circular No. 20 / 2025

Field Safety Corrective Action of Multiva 1.5T MR system from Philips Healthcare (Suzhou) Co., Ltd.

URGENT Field Safety Notice

Potential for System Shutdown and Magnet Bore Cover Thermostability Issue

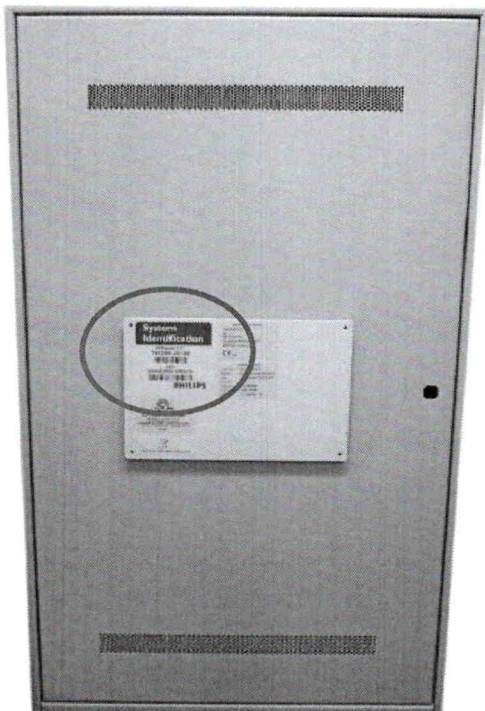
Figure 2: Front door of gMDU

- 3.1. Enter the Technical Room
- 3.2. Locate the general Mains Distribution Unit (gMDU) and Liquid cooling cabinet (LCC)
- 3.3. The system label is located on the front door of the gMDU (see figure 2) or LCC (see figure 3)
- 3.4. Locate the serial number on the system identification label (see figure 4)
