Circular No. 239/2023

Field Safety Notice of Multiva 1.5T MR Systems from Philips Healthcare.

### Multiva 1.5T

Gradient Coil component failure may act as a heat source with potential to produce smoke and/or fire.

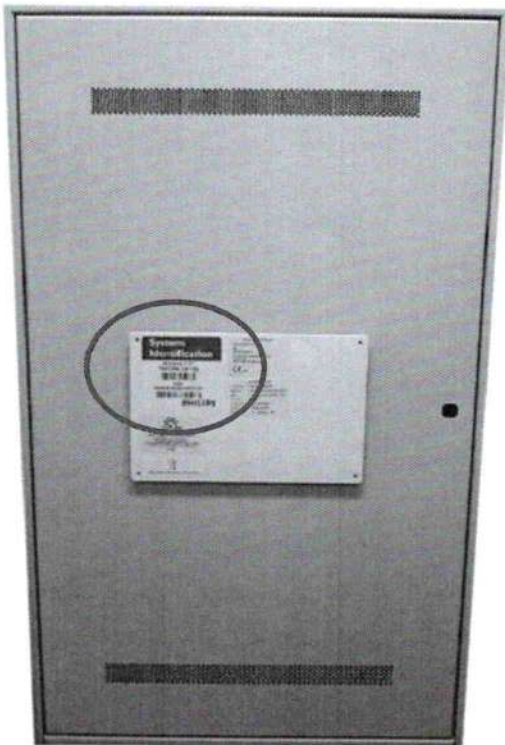
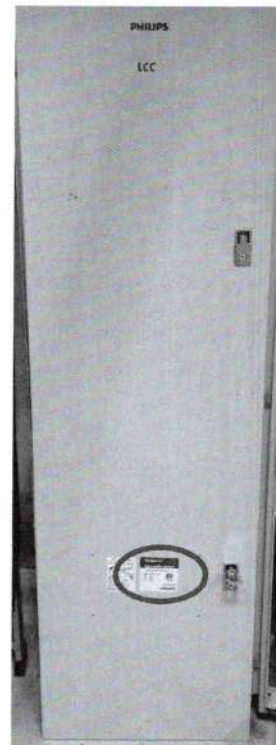
Figure 2: Front door of gMDU

- 3.1. Enter the Technical Room
- 3.2. Locate the general Mains Distribution Unit (gMDU) and Liquid cooling cabinet (LCC)
- 3.3. The system label is located on the front door of the gMDU (see figure 2) or LCC (see figure 3)
- 3.4. Locate the serial number on the system identification label (see figure 4)

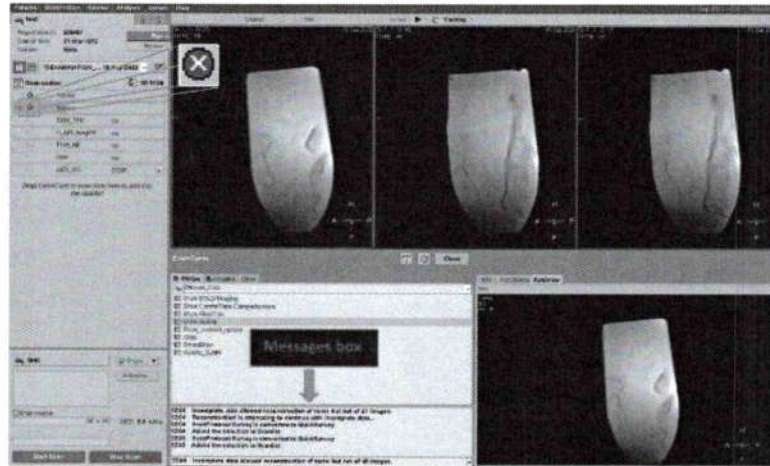
Figure 6. UI example SW Version R5.

- 4.3. When scan aborts occur the symbol is shown and applicable messages are presented in the message box (see Figure 6 examples)
  - 4.3.1. Check the status of the error messages in the User Interface (UI) screen. Click to expand the message box in case previous messages are hidden, see orange box in Figure 6 below. If possible, correct the issue that is relevant to the error shown, and continue scanning, for example:

- 4.3.2. If, after a scan abort, one of the following conditions occur five times in a row stop scanning immediately and contact Philips Service to describe the problem:

- If there is no error message in the message box
  - If the error message meaning is not clear
- 4.3.3. If the error message “Gradient amplifier Rack Fault” is received two times in a row, or if the error message “Gradient amplifier Rack Fault” is preceded or followed by an aborted scan with no message, then stop scanning immediately and contact Philips Service to describe the problem.

- 4.3.4. If you encounter any of these conditions described in 4.3.2 or 4.3.3 do not attempt any additional/further scans, including without limitation do not attempt any phantom scanning until your system has been checked and released by a Philips Service representative.

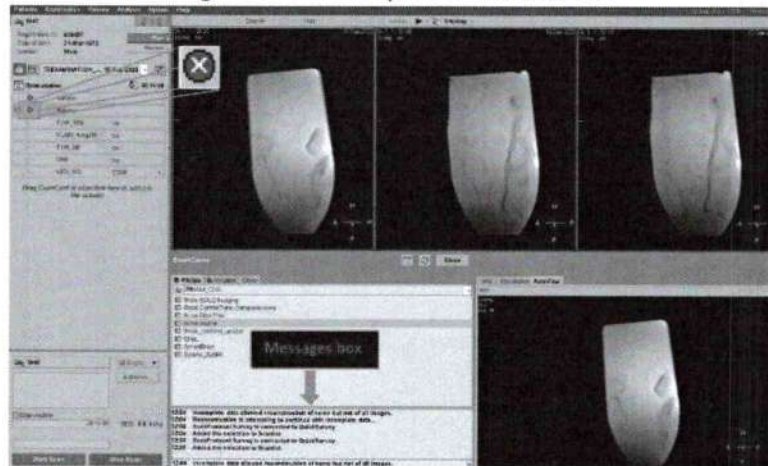
Figure 6. UI example SW Version R5.

- 4.3. When scan aborts occur the symbol is shown and applicable messages are presented in the message box (see Figure 6 examples)
  - 4.3.1. Check the status of the error messages in the User Interface (UI) screen. Click to expand the message box in case previous messages are hidden, see orange box in Figure 6 below. If possible, correct the issue that is relevant to the error shown and continue scanning, for example:
    - “RF door must be closed while performing scan. Scan aborted.”
    - “Patient support is moved while scanning, scan stopped.”
    - “Coil A (or B) failure, coil disconnected?”.

- 4.3.2. If, after a scan abort, one of the following conditions occur five times in a row stop scanning immediately and contact Philips Service to describe the problem:
  - If there is no error message in the message box
  - If the error message meaning is not clear
- 4.3.3. If the error message “Gradient amplifier Rack Fault” is received two times in a row, or if the error message “Gradient amplifier Rack Fault” is preceded or followed by an aborted scan with no message, then stop scanning immediately and contact Philips Service to describe the problem.

4.3.4. If you encounter any of these conditions described in 4.3.2 or 4.3.3 do not attempt any additional/further scans, including without limitation do not attempt any phantom scanning until your system has been checked and released by a Philips Service representative.
