Circular No. 162 / 2024

Field Safety Corrective Action of Philips Allura Xper R7.6- R8.1 system from Philips Medical Systems Nederland B.V.

## URGENT Field Safety Notice

### Philips Allura Xper R7.6- R8.1 systems

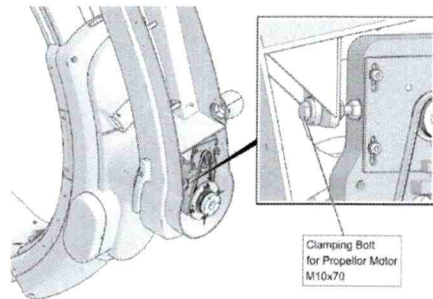
Figure 1: Clamping bolt of the C-arm propeller drive

Philips has identified potential safety issues with delayed LTE kit installations for Allura R7.6-R8.1 systems exceeding 10 years of life. The kit includes a propeller motor clamping bolt (see Figure 1) and the X-ray tube locking bolt (see Figure 2). If one of these bolts breaks, part of the system will not function as expected.

If the installation of the LTE kit is delayed, breakage of the propeller motor clamping bolt and/or the X-ray tube locking bolt may be expected. If this occurs,

Philips will contact all affected customers to arrange for a Field Service Engineer visit to install a Lifetime Extension Kit (reference FCO72200598). As of the date of this Urgent Field Safety Notice, Philips expects the solution to be available by Q1 2025.

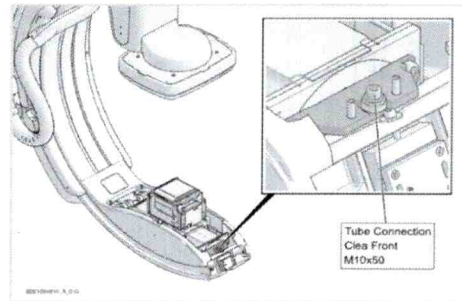
Figure 2: Locking bolt of the X-ray tube

A broken X-ray tube locking bolt could cause a black area to appear on the X-ray image, which may obscure the area of interest. This may require repeat imaging (up to 1 or 2 additional X-ray images or 3D scans), leading to additional radiation exposure. However, this additional radiation is not expected to exceed the thresholds for tissue reactions set by the International Commission on Radiological Protection (ICRP) for the risk of illness or injury.

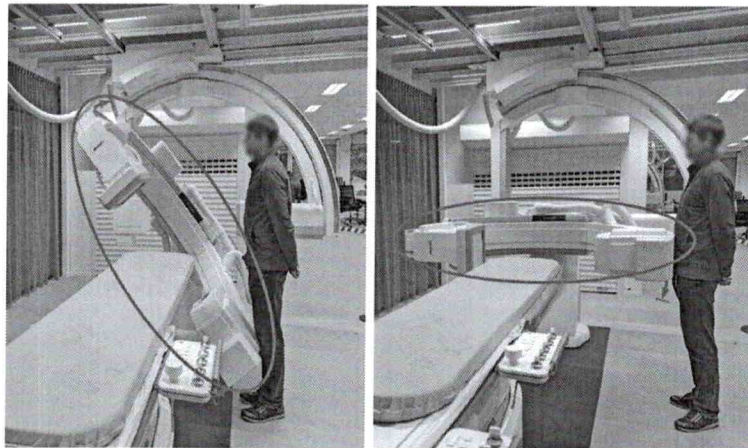
- The broken propeller motor clamping bolt may cause erratic C-arm movements, and potentially colliding with patients or bystanders (see Figure 3). These unbalanced movements may also cause the system to falsely detect a collision, consequently blocking motorized C-arm movements.
- The broken X-ray tube locking bolt may cause the tube to hit the cover, causing unexpected noise and the appearance of a black area (maximum up to 25%) on the X-ray image. Consequently, the area of interest in the X-ray image may be obscured, leading to the need for an additional scan.

Figure 3: Erratic movements of C-arm (red circle) due to broken propeller motor clamping bolt.

A broken propeller motor clamping bolt could cause erratic C-arm movements, potentially resulting in the tube or the detector hitting staff or patients, leading to minor physical injuries (Example: hematoma/bruises, scratches, small cuts, or skin abrasions). Additionally, these erratic movements may trigger false collision detections, blocking all C-arm motorized movements and potentially delaying diagnosis or treatment.
