**Circular No. 216/2022**

**Field Safety Corrective Action of Philips Laser System (LAS-100) from Spectranetics Corporation**

## URGENT Field Safety Notice

Philips Laser System (LAS-100) with software version number 0.5.0.3

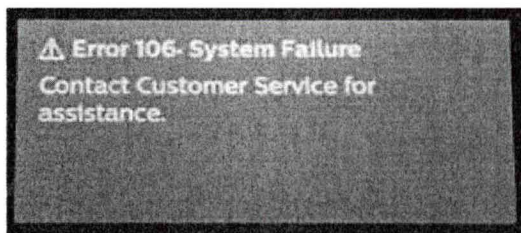
Figure 1: Example of an Error 106 visual alert

- Error 106 is triggered when the actual ratio of energy between the Prism Energy Sensor (PES) and Vessel Energy Sensor (VES) differs from the expected (calculated) ratio (this is also known as sensor mismatch error), and in all complaints, Error 106 is triggering under conditions where it should not trigger (false positive).
- Error 108 is triggered when the PLS detects that 10 or more of the last 100 pulses were invalid (missing), and in all complaints, Error 108 is triggering under conditions where it should not trigger (false positive).

1. System restart
2. Recalibration of the catheter in use or calibration of a new catheter

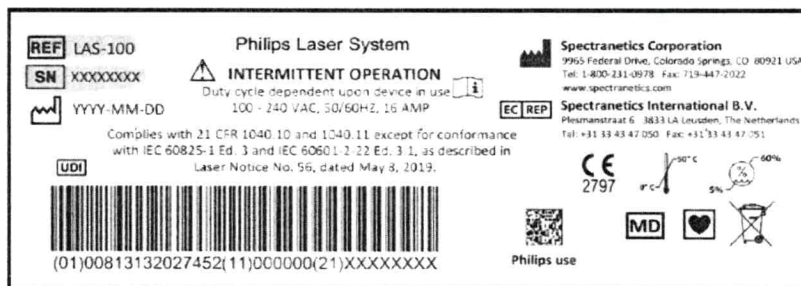
Only the Philips Laser Systems (PLS), model number LAS-100, with software version number 0.5.0.3 are affected. The model and serial number of the PLS are printed on the primary label on the back of the device as shown below. The version of the software can be found under Settings (gear icon).
