**Circular No. 191 / 2023**

**FSCA of A Subset of Gallant™, Neutrino™ Nxt, and Entrant™ Icds and Crt-Ds from Abbott.**

**FA-Q122-CRM-2 URGENT Field Safety Notice**  
**FOR A SUBSET OF GALLANT™, NEUTRINO™ NxT,**  
**AND ENTRANT™ ICDs AND CRT-Ds**  
**MANUFACTURED PRIOR TO APRIL 2022**  
MODELS CDVRA500Q, CDDRA500Q, CDHFA500Q, CDVRA600Q,  
CDDRA600Q, CDHFA600Q, CDVRA300Q, CDDRA300Q, AND CDHFA300Q

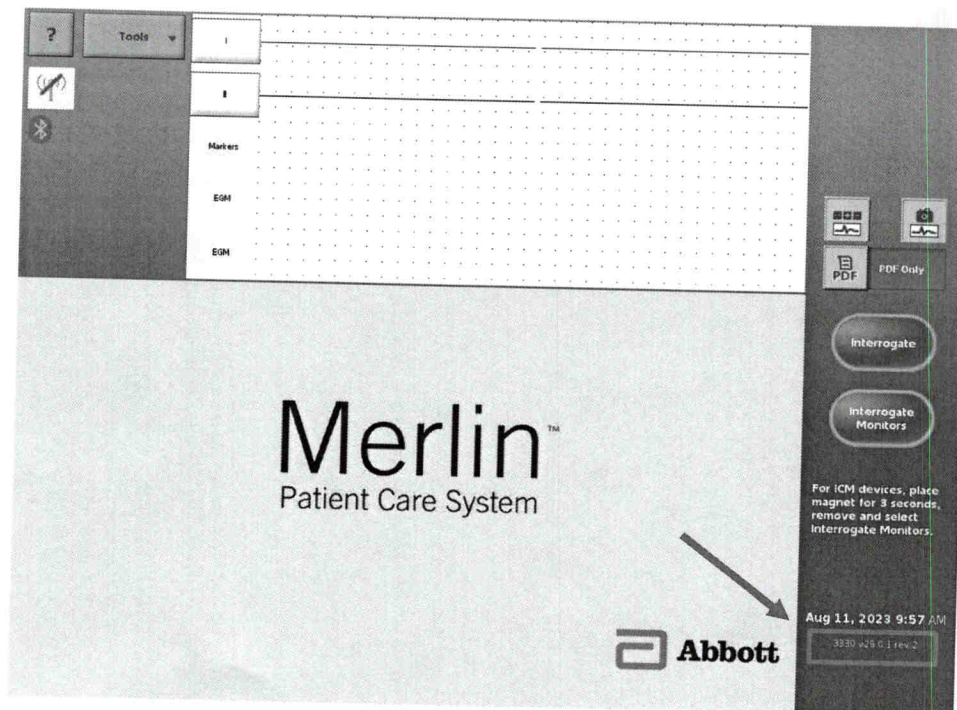
Image 2: Merlin™ PCS 3650 software version visible on the startup screen

The Merlin™ PCS 3650 software version is visible on the lower right corner of the initial startup screen, as displayed in the image below. Confirm the programmer software version is 3330 v25.8.2. rev. 1 or higher.
