Circular No. 89 / 2024

Field Safety Corrective Action of Multiva 1.5T systems equipped with g-MDU from Philips Healthcare.

## URGENT Field Safety Notice

Multiva 1.5T systems Terminal connections in the general Mains Distribution Unit (g-MDU) may produce a Thermal Event

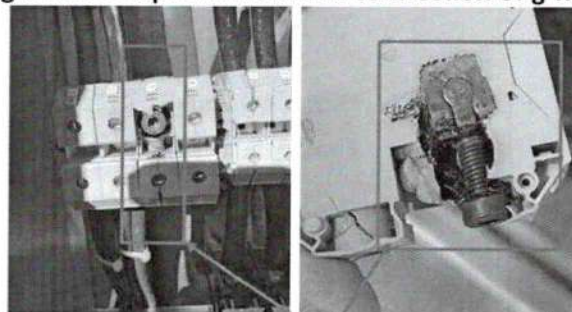
**Figure 1. Hotspot on terminal connection of g-MDU**

Philips has identified an issue where the g-MDU (global Mains Distribution Unit) L3 terminal connection may become loose creating a hotspot (see figure 1) that may cause smoke/fire to alarm in the hospital's technical room. The g-MDU, located in the technical room, is the single-entry point for the hospital electricity supply and distributes the electricity toward the various cabinets and components of the MR Scanner.

L3 Terminal Connection

Philips will contact you to schedule time for a Field Service Engineer (FSE) to visit your site to inspect the g-MDU connections in the technical room and apply the proper torque to the connection if necessary. (reference FCO78100583). Philips plans to start implementing corrections in July 2024.
