Circular No. 40/2022

**Field Safety Corrective Action of MiniMed 780G insulin pump from Medtronic MiniMed.**

**Urgent Field Safety Notice**  
**MiniMed™ 780G insulin pump: MMT-1885, MMT-1886**  
**Pump Errors After Quick Bolus**

Medtronic reference: FA963

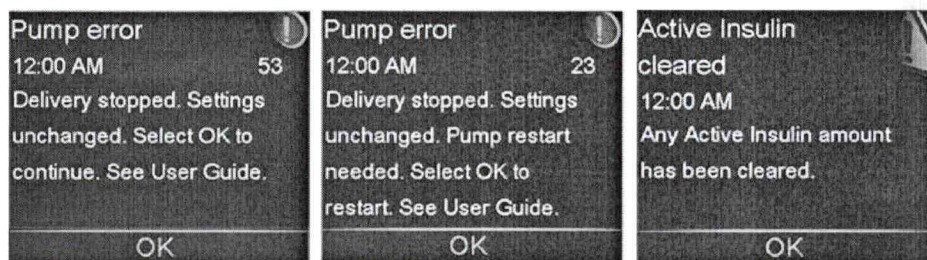
If all the above conditions are met, within 2 minutes of bolus delivery completion, the pump initiates Pump error 53, followed by Pump error 23 alarm. The following screens are presented in the pump screen:

Upon clearing the pump errors, the pump resets and indicates Active Insulin has been cleared. The pump then guides the user to resume operation in Manual Mode. The SmartGuard™ status screen

**Since Active Insulin will display 0.0 units in the pump after experiencing the pump errors above, if the user is not aware of the amount of active insulin and delivers an additional bolus, there is a risk of insulin over delivery, which may result in low blood sugar (hypoglycemia) or severe hypoglycemia. In rare cases, severe hypoglycemia, if left untreated, may lead to a life-threatening situation.** As of January 21, 2021, Medtronic has received no reports of serious patient harm or serious injury related to this issue.

1. Although insulin was delivered before the error and they may have insulin on board, Active Insulin is reset to 0.0 units on the pump screen.
2. Before delivering additional boluses, check their graph or history to understand how much insulin was delivered before the error.
3. Consult with their healthcare professional about their active insulin absorption and how to plan a bolus if active insulin has been reset to 0.0.

1. **Wait** at least 2 minutes between boluses if they need to deliver multiple boluses that exceed 17.1U in total.
2. **Consult** with their healthcare professional about setting their maximum bolus limit to 17U or less. *Note: The default setting is 10U.*

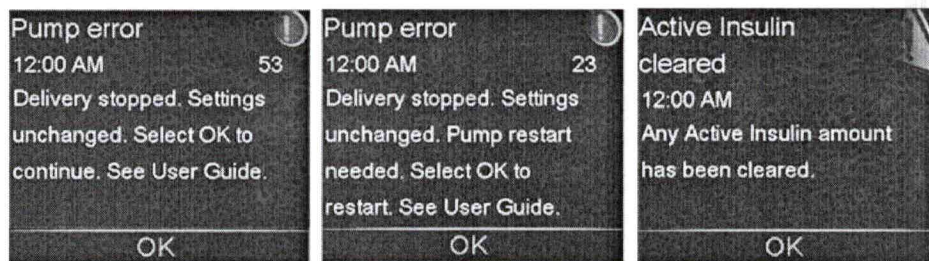
If all the above conditions are met, within 2 minutes of bolus delivery completion, the pump initiates Pump error 53, followed by Pump error 23 alarm. The following screens are presented in the pump screen:

Upon clearing the pump errors, the pump resets and indicates Active Insulin has been cleared. The pump then guides the user to resume operation in Manual Mode. The SmartGuard™ status screen indicates the warm-up period has started. After approximately 5 hours, the SmartGuard™ feature will be available.

Since Active Insulin will display 0.0 units in the pump after experiencing the pump errors above, if the user is not aware of the amount of active insulin and delivers an additional bolus, there is a risk of insulin over delivery, which may result in low blood sugar (hypoglycemia) or severe hypoglycemia. In rare cases, severe hypoglycemia, if left untreated, may lead to a life-threatening situation. As of January 21, 2021, Medtronic has received no reports of serious patient harm or serious injury related to this issue.

1. Although insulin was delivered before the error and you may have insulin on board, Active Insulin is reset to 0.0 units on the pump screen.
2. Before delivering additional boluses, check your graph or history to understand how much insulin was delivered before the error.
3. Consult your healthcare professional about your active insulin absorption and how to plan a bolus if active insulin has been reset to 0.0.

1. **Wait** at least 2 minutes between boluses if you need to deliver multiple boluses that exceed 17.1U in total.
2. **Consult** your healthcare professional about setting your maximum bolus limit to 17U or less.  
*Note: The default setting is 10U.*
