Circular No. 34 / 2023

Field Safety Corrective Action of BD Trucount™ Tubes from Becton Dickinson & Co. (BD).

PRODUCT NOTIFICATION – BDB-22-4547-B

BD Trucount™ Tubes

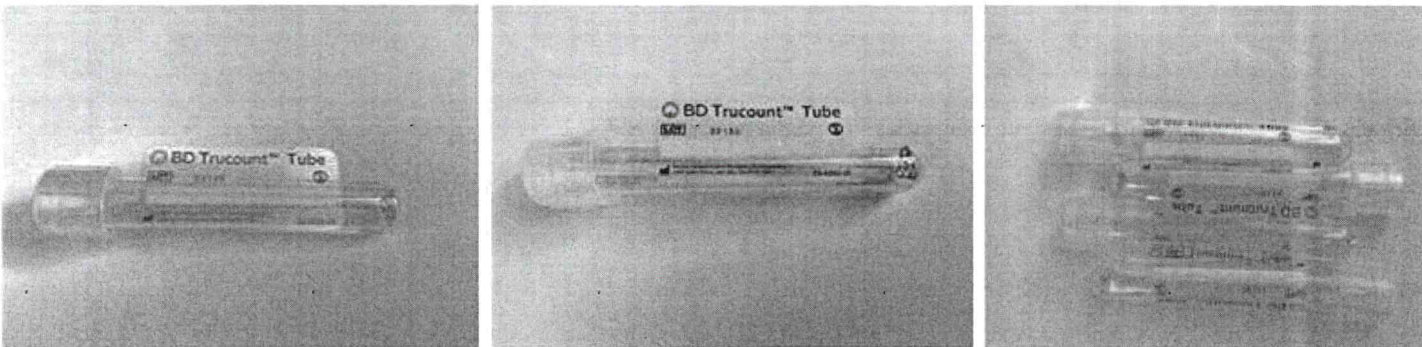
Based on customer feedback, BD has identified an adhesive change made at a supplier that results in the inadequate adhesion of the labels applied to the BD Trucount™ Tubes. This results in the BD Trucount™ Tube labels becoming detached as shown in the pictures below:

Note: The BD Trucount™ Tube product performance is not impacted by the label detachment issue.

BD has investigated this issue and identified that an adhesive change made by a supplier has resulted in the inadequate label adhesion. BD is working closely with the supplier to resolve this situation expediently.

1. Circulate this product notification to all those within your organisation that may use the **BD Trucount™ Tubes**.
2. If you have further distributed the product, please identify those users and notify them at once of this advisory. Ensure they follow the instructions listed in this Product Notification.
3. For any tube where label detachment is observed, BD recommends that the user removes the label from the tube and, using a permanent marker, record the tube lot number as well as any other identification numbers directly on the tube as shown:

1) Use one BD Trucount™ Tube lot at a time	2) Remove label from the tube	3) Write lot number and relevant information on the tube
