**Circular No. 216/2022**

**Field Safety Corrective Action of Philips Laser System (LAS-100) from Spectranetics Corporation**

## URGENT Field Safety Notice

Philips Laser System (LAS-100) with software version number 0.5.0.3

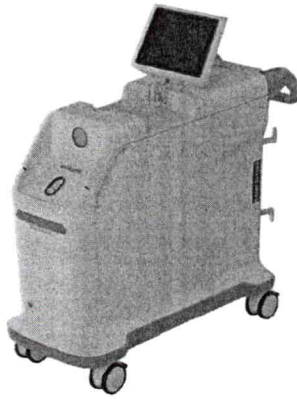
Figure 3: LAS-100 Philips Laser System

Philips has identified an intermittent software issue with the LAS-100 Philips Laser Systems. For affected units, having software version 0.5.0.3, the system may detect an error that will visually alert the user on the system display as "Error 106 – System Failure" or "Error 108 – System Failure" as described below:

- Error 106 is triggered when the actual ratio of energy between the Prism Energy Sensor (PES) and Vessel Energy Sensor (VES) differs from the expected (calculated) ratio (this is also known as sensor mismatch error), and in all complaints, Error 106 is triggering under conditions where it should not trigger (false positive).
- Error 108 is triggered when the PLS detects that 10 or more of the last 100 pulses were invalid (missing), and in all complaints, Error 108 is triggering under conditions where it should not trigger (false positive).

Philips recommends the continued use of the Philips Laser System, and to follow the Operator's Manual. As a temporary mitigation, until software becomes available tentatively in Q2 2023, the user can perform steps when visually alerted on the system display as follows:
