Circular No. 89 / 2024

Field Safety Corrective Action of Multiva 1.5T systems equipped with g-MDU from Philips Healthcare.

## URGENT Field Safety Notice

Multiva 1.5T systems Terminal connections in the general Mains Distribution Unit (g-MDU) may produce a Thermal Event

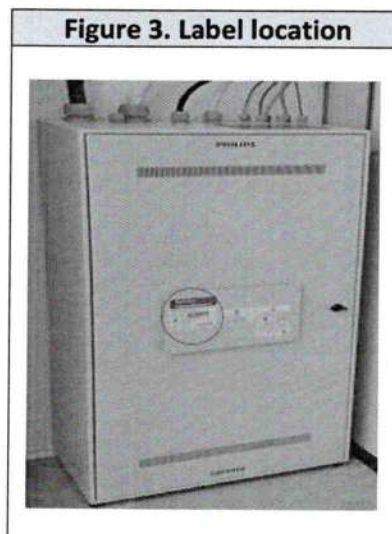
- Enter the Technical Room
- Locate the Mains Distribution Unit (gMDU)
- The label is located on the front door of the gMDU, (see Figure 3)
