Circular No. 34 / 2023

Field Safety Corrective Action of BD Trucount™ Tubes from Becton Dickinson & Co. (BD).

PRODUCT NOTIFICATION – BDB-22-4547-B

BD Trucount™ Tubes

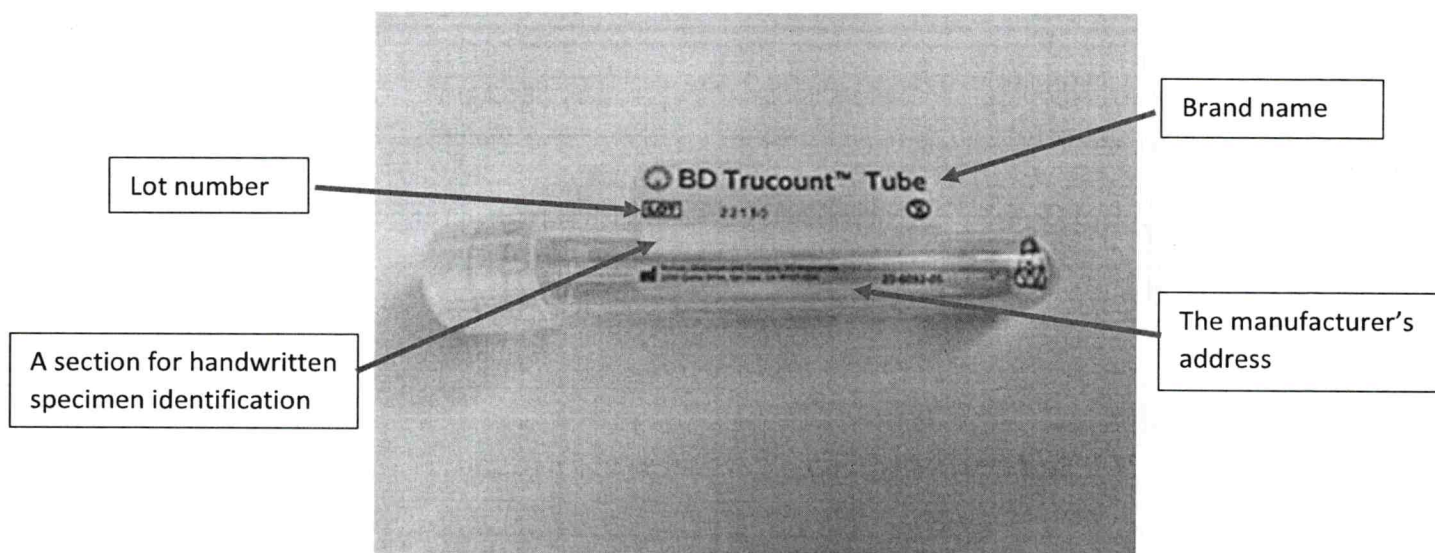
Appendix 2 – Label details

The issue could potentially cause automation errors when BD Trucount™ Tubes are used with the automated loader for the BD FACSCalibur™, the BD FACSCanto™, and the BD FACS™ Lyse Wash Assistant. In these instruments, the loader moves the tube to the probe, the tube is lifted from its position in the loader for sampling, and then it is replaced into its position in the loader. If the label is partially detached, the tube cannot be fully replaced into its position in the loader. Please refer to Appendix 2 for information on what is included on the label.
