Circular No. 122/2023

Field Safety Corrective Action of Intellivue Mx40 Patient Monitor from Philips Healthcare.

URGENT Field Safety Notice
INTELLIVUE MX40 PATIENT MONITOR

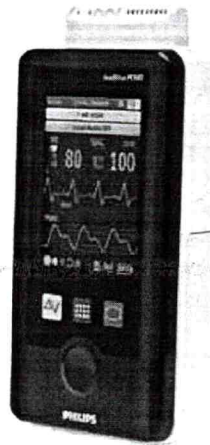
Figure 1 – MX40 device

When the MX40 is in Standby mode for an extended period without patient surveillance no monitoring or alarming is available because alarms, as designed, cannot be triggered when the MX40 is in standby mode.

2) if Infinite duration is used for Standby mode, the device will not resume monitoring until Standby is manually ended by the user or a "Tele Battery Low" INOP condition occurs. While the MX40 device is in Standby, physiological monitoring and alarming is stopped.

Therefore, there may be a hazardous situation present if a user places an MX40 in Standby longer than intended for completion of a patient procedure or test if the device is not taken out of Standby.

Please refer to the instructions in the IFU before using standby mode, see Sections: *Standby Behavior*, *Unit Configurable Settings* and *Global Settings*.

- To resume monitoring from Standby mode, Press the blue Main Screen Button or disconnect/reconnect the MX40 patient cable.
- If the MX40 is placed in a timed Standby mode duration (i.e., not Infinite), a Standby mode timer is displayed on the MX40 screen. If in infinite Standby mode, the *Standby* message is always displayed until the device sleeps. **Remember, when the device has been placed in Standby mode without the user choosing a time for when monitoring will resume (i.e., after 10, 20, 30**
